Tolna Dam

Tolna Coulee Trib. Of The Sheyenne River Red River of The North Basin Nelson County North Dakota Fed. ID No. ND 00027 SWC proj No. 266

Phase 1 Inspection Report National Dam Safety Program

Owned By Nelson County W. M. D. Inspected: October 21, 1980 REINSPECTED DATE 8-5-92

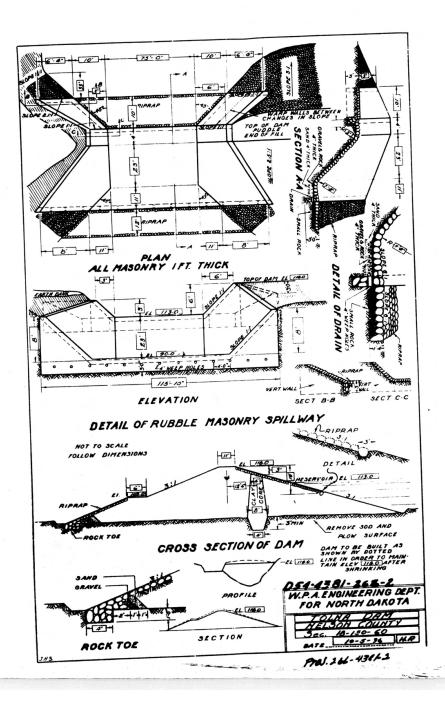
Plate C-2

3.7. <u>Principal Outlet</u>. The principal outlet is a reinforced concrete chute controlled by a weir 77'-6" in length. Details of this structure are shown on Plates C-1 and C-2. The total drop is 25 feet. There is no stilling basin. This structure is located on natural ground beyond the right abutment.
